Present Landfill Monitoring and Maintenance Plan and Post-Closure Plan U.S. Department of Energy Rocky Flats Site

March 2008

Work Performed by S.M. Stoller Corporation under DOE Contract No. DE-AM01-07LM00060
for the U.S. Department of Energy Office of Legacy Management, Grand Junction, Colorado

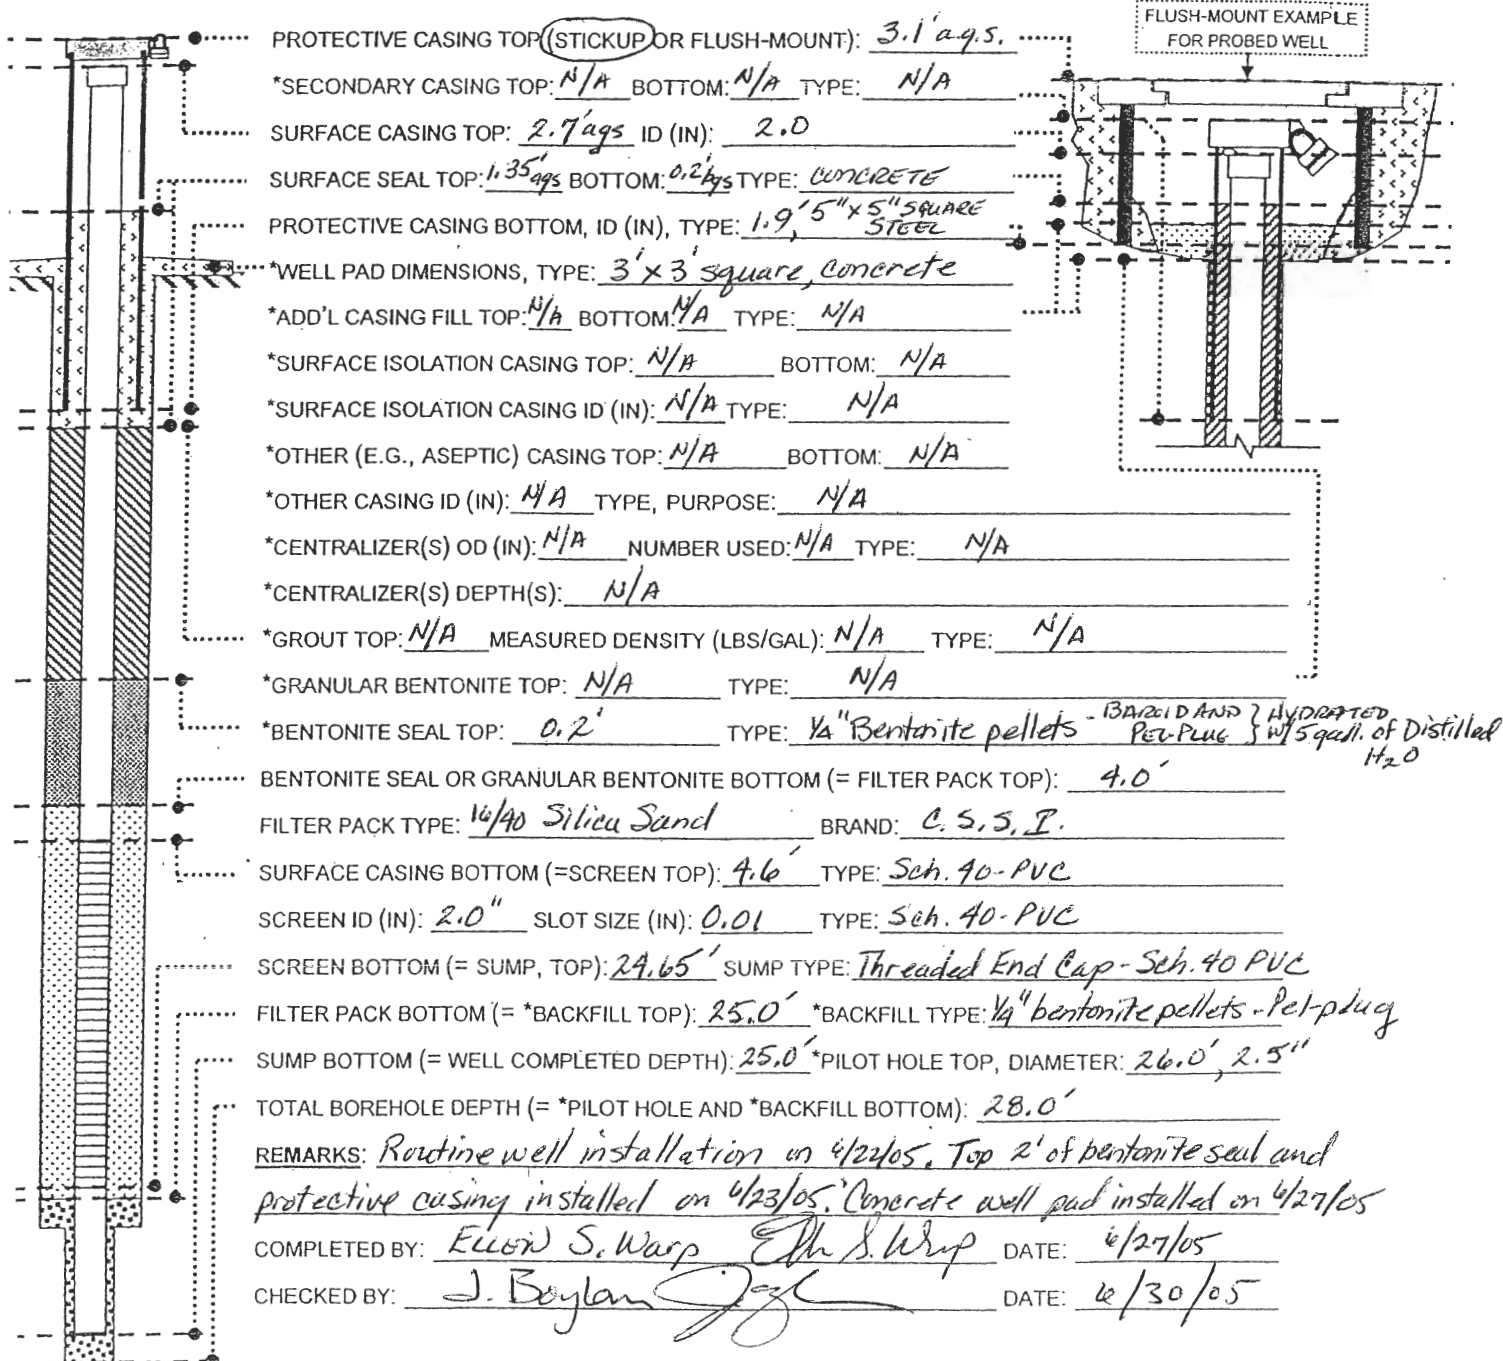
PROTECTIVE CASING TOP (STICKUP OR FLUSH-MOUNT): 3.1' a.g.s.

*SECONDARY CASING TOP: N/A BOTTOM: N/A TYPE: N/A
